**Flood Control Project Maintenance
Levee Inspections**
LMA District Cover Sheet
Spring 2018 Levee Inspection Results

Reclamation District No. 0556 Upper Andrus

Spring 2018 Levee Inspection Results

Waterway			Bank	Unit Miles
Unit No. 01 Georgiana Slough			Right	5.48
	Spring (March - May)	Summer (June - August)	(September - November) Fall	Winter (December - February)
Unit Maintenance Rating (Fall Only)				
Date of Inspection	4/5/2018 - 4/5/2018			
DWR Inspector	Keith Millard			
Accompanied By	Alan Silva RD 556

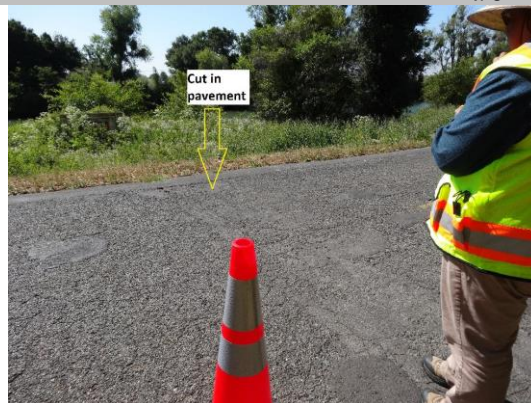
Photo 2 of 3 : UCIP_SP_2018_45564_74146.jpg

LM Start	0.44	Rating **	M	Issue No.	387 (cont)
LM End	0.44	Issue Type +	En	Location *

View of WS; cut in pavement in alignment with arrow and Olivia indicating location of crossing trench.

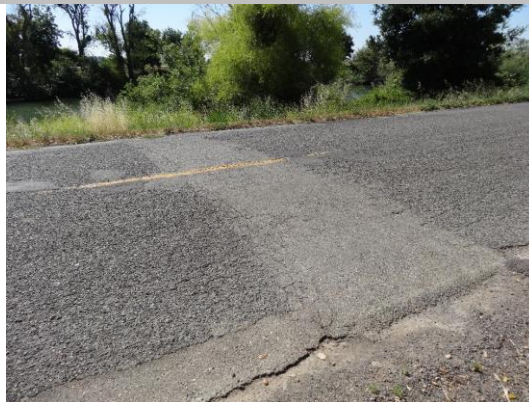
Photo 2 of 3 : UCIP_SP_2018_45663_74181.jpg

LM Start	0.53	Rating **	M	Issue No.	388 (cont)
LM End	0.53	Issue Type +	En	Location *

View of WS with cuts visible on pavement.

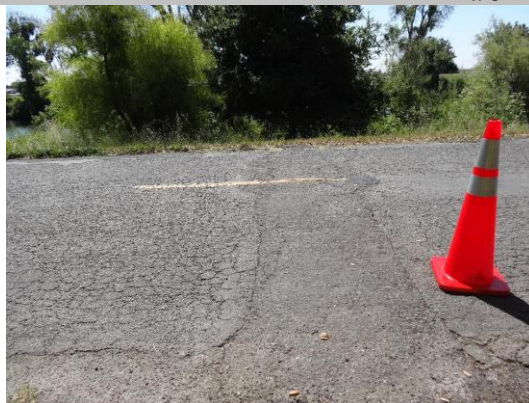
Photo 2 of 3 : UCIP_SP_2018_45664_74191.jpg

LM Start	0.54	Rating **	M	Issue No.	389 (cont)
LM End	0.54	Issue Type +	En	Location *

View of WS with cuts visible on pavement.

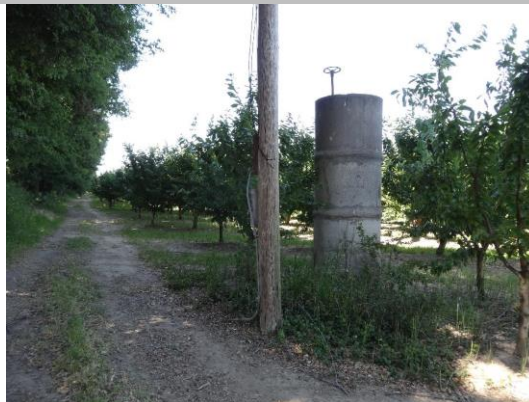
Photo 3 of 3 : UCIP_SP_2018_45664_74192.jpg

Standpipe and service pole visible off LS toe.

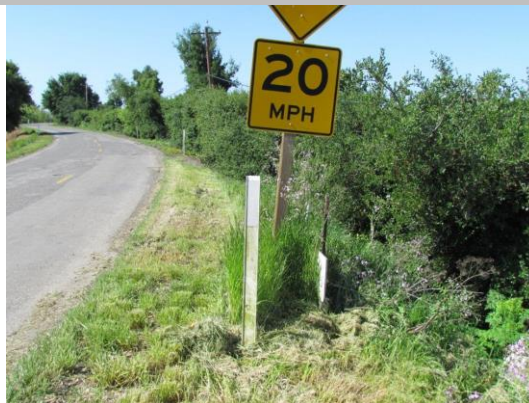
Photo 1 of 1 : SP_2018_RD0556_18_10_20180305_00003.jpg

LM Start	0.93	Rating **	U	Issue No.	10
LM End	1.54	Issue Type +	Ma	Location *	LS
Category	Earthen Levee			GPS Latitude/Longitude	
				Start	End
Item	Trim / Thin Trees			38.228295 °	38.225368 °
				-121.526688 °	-121.534677 °
DWR ID	DWR_RD0556_01_f_2015_10				
Comment Code					
T3 : Trim and thin trees to allow visibility of the ground and room to flood fight.					
Inspector Comment					
Thin out and remove the wild tree growth and vegetation on the landside levee slope and shoulder.

RD 556 Unit 1 levee miles 0.93-1.54 looking downstream landside slope.

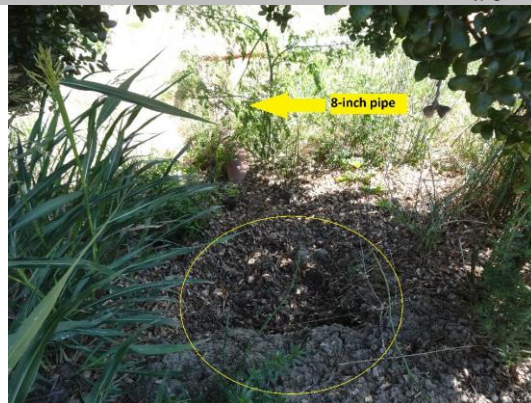
Photo 1 of 3 : UCIP_SP_2018_46799_74739.jpg

LM Start	1.17	Rating **	M	Issue No.	390
LM End	1.17	Issue Type +	En	Location *	
Category	Supplemental			GPS Latitude/Longitude	
				Start	End
Item	DWR UCIP Field Study			38.227534 °	38.227534 °
				-121.529396 °	-121.529396 °
DWR ID					
Comment Code					
Inspector Comment					
FS_ID:46799					
DS_ID:25106					
EP_NO: N/A					
Repair Type: Non-Urgent					
Crossing Status: Found					
UCIP Comments: Possible erosion above pipe on LS needs attention.					
FIELD_STRUCT_DESC: 8-inch steel irrigation pipe through the levee, at an unknown depth. Visible on the landside (LS), 6 feet away from the 10-inch pipe at HLM 1.17. Post likely for protection of vent located on the shoulder. Power pole next to pipe on the LS. This crossing was field discovered.					
FS Date: 5/27/2015

LS view: 8-inch pipe off LS slope with possible erosion above pipe (circled).

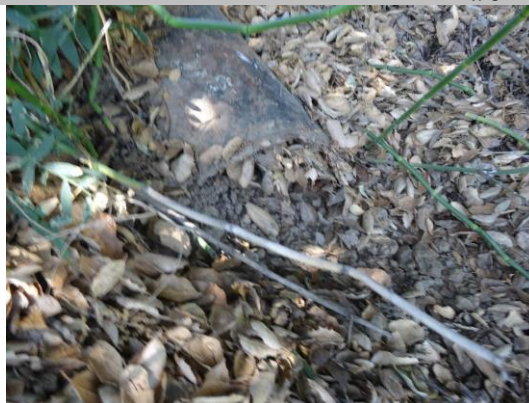
Photo 2 of 3 : UCIP_SP_2018_45683_74201.jpg

Comment Code						
Inspector Comment						
FS_ID:45683 DS_ID:20823 EP_NO: 11169 Repair Type: Non-Urgent Crossing Status: Found UCIP Comments: Appears abandoned in place and if so should be done so properly. Desnse vegetation on WS limits visibility. FIELD_STRUCT_DESC: *ABANDONED* 10-inch steel irrigation discharge pipe through the levee, 3.8 feet below the crown. Located at the lower end of the rock revetment. (Plans to replace an existing 10-inch suction pipe with a 10-inch slant propeller pump on the levee authorized under Permit No. 4848, 1965 - Kay Dix Ranch Company. Retention of a 10-inch pipe through the levee, 3.8 feet below the crown, authorized under Automatic Board Order (ABO) issued as Permit No. 11169, 1975 - Darrell T. and B. M. Mealer). Abandoned in place. [Additional Reference(s): DWR Levee Log. USACE Sacramento O&M Manual 103, June 1954, (Station ""R"" 548+59.8), invert elevation 16.8 feet]. FS Date: 5/27/2015

Closeup of abandoned pipe.

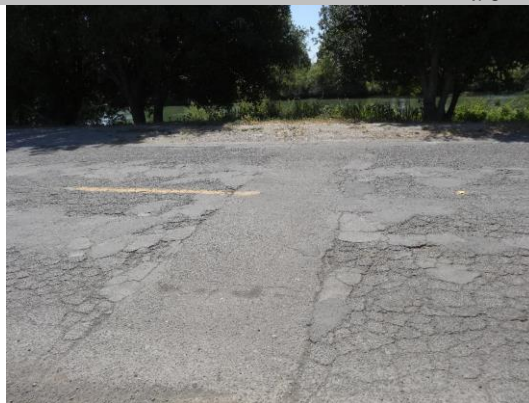
Photo 2 of 3 : UCIP_SP_2018_45692_74205.jpg

FS_ID:45692
DS_ID:20825
EP_NO: 13302
Repair Type: Non-Urgent
Crossing Status: Found
UCIP Comments: Seal beneath siphon breaker off LS toe leaking. Rodent activity near crown off LS shoulder. Need to contact owner about leaky seal. Dense vegetation prevented inspection of WS slope. FIELD_STRUCT_DESC: 6-inch steel irrigation discharge pipe and 2-inch galvanized iron electrical conduit through the levee, 2 feet below the crown. Siphon valve on the landside (LS) shoulder. Concrete stand and pump at the LS toe. Circuit box also at the LS toe. Cuts visible in pavement. 6-inch polyvinyl chloride (PVC) standpipe adjacent to the pipe off the LS toe. (Plans to install a 6-inch irrigation pipe and electrical conduit through the levee authorized under Permit No. 13302, 1981 - Kaydix Ranch). [Additional Reference(s): DWR Levee Log. USACE Sacramento O&M Manual 103, June 1954, (Station ""R"" 540+85), invert elevation 16.3 feet].

WS view and cuts visible on pavement.

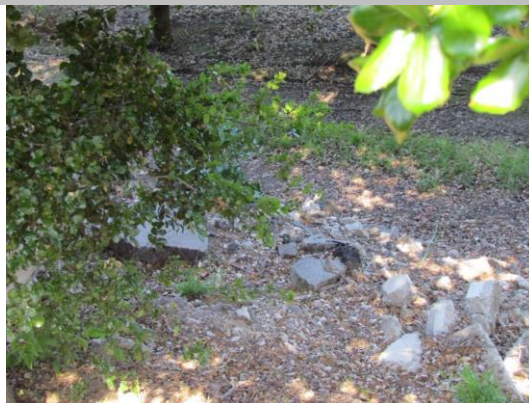
Photo 1 of 3 : SP_2018_RD0556_18_27_20180305_00010.jpg

LM Start	1.34	Rating **	U	Issue No.	27 (cont)
LM End	1.37	Issue Type +	En	Location *	LS

RD 556 Unit 1 levee mile 1.34-1.37 landside toe.

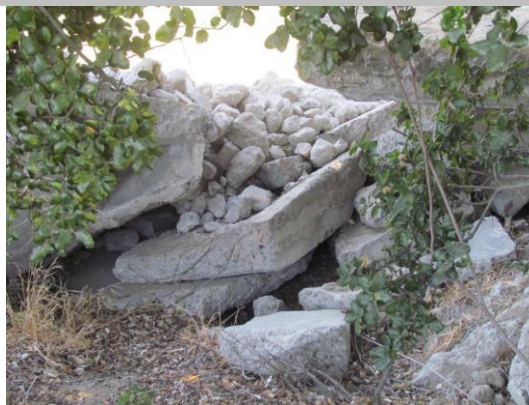
Photo 2 of 3 : SP_2018_RD0556_18_27_20180305_00011.jpg

RD 556 unit 1 levee miles 1.34-1.37 landside toe.

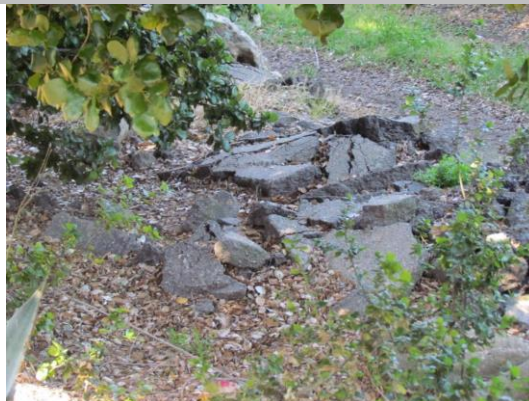
Photo 3 of 3 : SP_2018_RD0556_18_27_20180305_00012.jpg

LM Start	1.34	Rating **	U	Issue No.	27 (cont)
LM End	1.37	Issue Type +	En	Location *	LS

RD 556 Unit 1 levee mile 1.34-1.37 continuation of material on the toe.

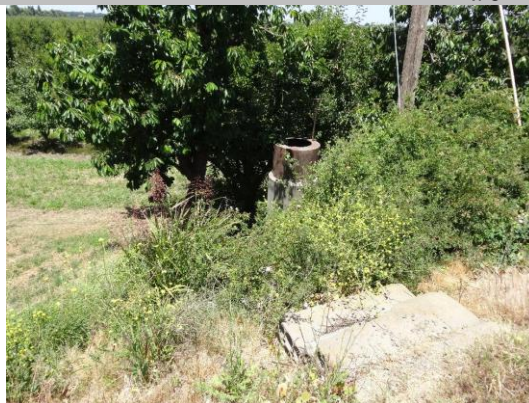
Photo 1 of 3 : UCIP_SP_2018_45743_74240.jpg

FS_ID:45743
DS_ID:20827
EP_NO: 11169
Repair Type: Non-Urgent
Crossing Status: Found
UCIP Comments: Dense vegetation on LS and WS limited accessibility.
FIELD_STRUCT_DESC: 8-inch steel irrigation discharge pipe through the levee, 3.5 feet below the crown. 1-inch air valve. Pump and gate valve on the waterside (WS) berm. 2-inch electrical conduit through the levee. 36-inch concrete standpipe and concrete block step on the landside (LS) slope. (Retention of a 10-inch pipe through the levee, 3.5 feet below the crown, and a pump and a gate valve on the WS berm authorized under Automatic Board Order (ABO) issued as Permit No. 11169, 1975 - Darrell T. and B. M. Mealer). [Additional Reference(s): DWR Levee Log, 10-inch pipe referenced. USACE Sacramento O&M Manual 103, June 1954, (Station ""R"" 528+02.1), 10-inch pipe referenced, invert elevation 16.6 feet].
FS Date: 5/27/2015

Concrete standpipe and steps off LS toe.

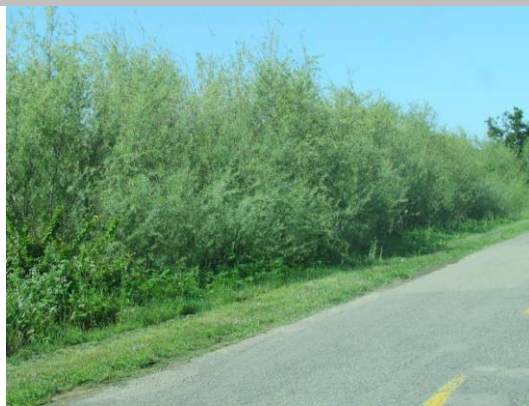
Photo 1 of 1 : SP_2018_RD0556_18_74_20180305_00031.jpg

LM Start	1.74	Rating **	U	Issue No.	74
LM End	2.29	Issue Type +	Ma	Location *	WS
Category	Earthen Levee			GPS Latitude/Longitude	
				Start	End
Item	Vegetation			38.224198 °	38.220317 °
				-121.537987 °	-121.544172 °
DWR ID	DWR_RD0556_01_f_2015_74				
Comment Code					
V7 : Trees / Woody Vegetation					
Inspector Comment					
Arundo and willows need to be removed. This vegetation completely blocks the view of the waterside slope, shoulder and toe.

RD 556 Unit 1 waterside levee mile 1.74-2.29.

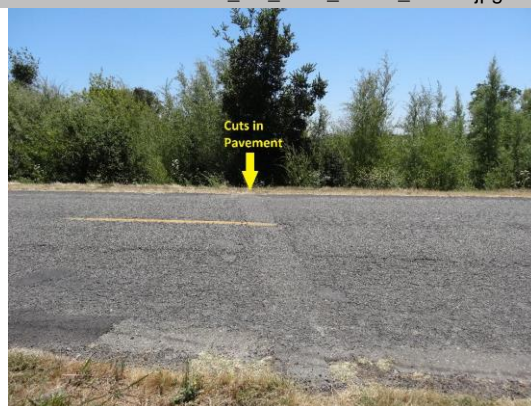
Photo 1 of 3 : UCIP_SP_2018_45746_74250.jpg

Comment Code					
Inspector Comment					
FS_ID:45746 DS_ID:20828 EP_NO: 3735 Repair Type: Non-Urgent Crossing Status: Indicator Found UCIP Comments: Dense vegetation on LS and WS limited accessibility. FIELD_STRUCT_DESC: 4-inch electrical conduit of an unknown material under Georgiana Slough and through its levees, 4 feet below the crown. Pump on the waterside (WS) berm. Power pole on the landside (LS) in alignment with the cuts in the pavement. (Plans for installation of a 12-kilovolt submarine cable under Georgiana Slough and through its levees authorized under Permit No. 3735, 1961 - Pacific Gas and Electric Company [PG&E]). [Additional Reference(s): DWR Levee Log]. FS Date: 5/27/2015

View of WS and cuts in pavement.

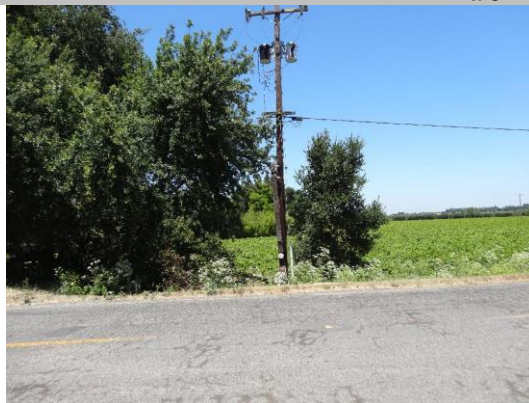
Photo 1 of 3 : UCIP_SP_2018_45764_74260.jpg

LM Start	1.89	Rating **	M	Issue No.	395 (cont)
LM End	1.89	Issue Type +	En	Location *

LS view: service pole on LW slope. Standpipe not visible in photo.

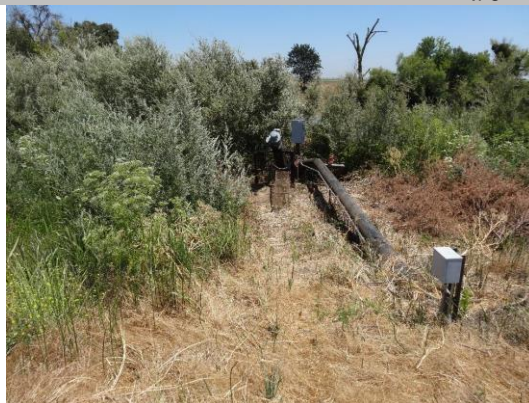
Photo 1 of 3 : UCIP_SP_2018_45786_74280.jpg

LM Start	2.13	Rating **	M	Issue No.	396 (cont)
LM End	2.13	Issue Type +	En	Location *

WS view: Slant pump, 12-inch and 1-inch pipe through levee.

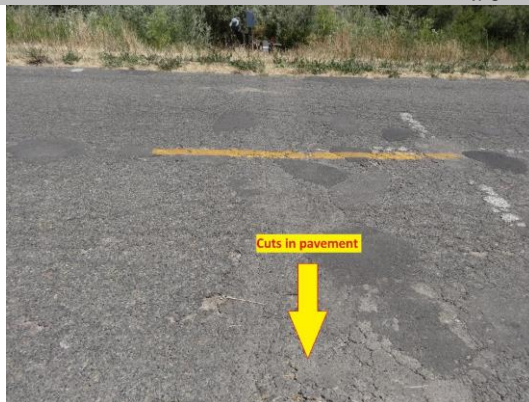
Photo 2 of 3 : UCIP_SP_2018_45786_74281.jpg

View toward WS with cuts in pavement in alignment with pipe on WS

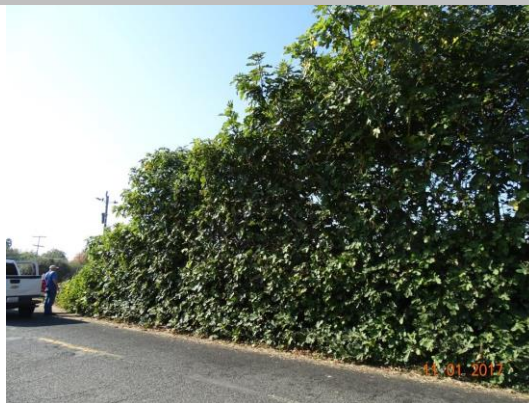
Photo 1 of 1 : SP_2018_RD0556_18_26_20180305_00009.jpg

LM Start	2.34	Rating **	U	Issue No.	26
LM End	2.34	Issue Type +	En	Location *	LS
Category	Earthen Levee			GPS Latitude/Longitude	
				Start	End
Item	Vegetation			38.219592 °	38.219592 °
				-121.543960 °	-121.543960 °
DWR ID	DWR_RD0556_01_f_2017_26				
Comment Code					
V6 : Landscaping					
Inspector Comment

Large fig tree should be trimmed to allow inspection and access to levee slope and toe.

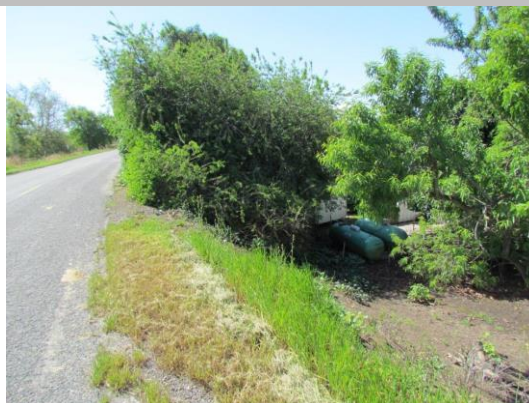
Photo 1 of 2 : SP_2018_RD0556_18_31_20180305_00016.jpg

LM Start	2.38	Rating **	U	Issue No.	31
LM End	2.43	Issue Type +	En	Location *	LS
Category	Earthen Levee			GPS Latitude/Longitude	
				Start	End
Item	Vegetation			38.219037 °	38.218342 °
				-121.543847 °	-121.543842 °
DWR ID	DWR_RD0556_01_s_2017_31				
Comment Code					
V6 : Landscaping					
Inspector Comment

Looking downstream from the landside shoulder woody tree growth blocking the slope and shoulder.

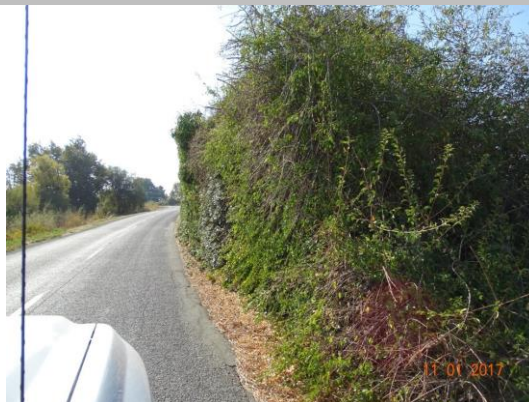
Photo 2 of 2 : SP_2018_RD0556_18_31_20180305_00017.jpg

LM Start	2.38	Rating **	U	Issue No.	31 (cont)
LM End	2.43	Issue Type +	En	Location *	LS

Trim and thin trees to allow visibility of the slope and ground.

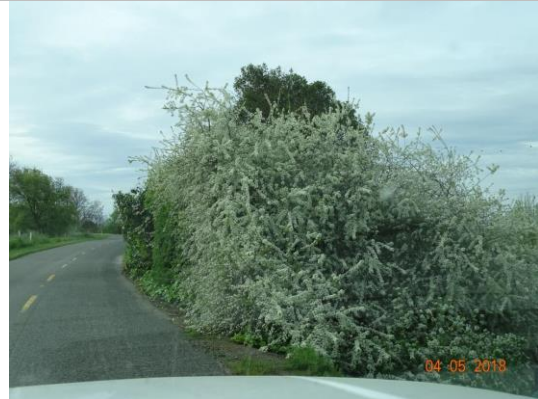
Photo 1 of 1 : SP_2018_RD0556_18_50_20180409_00068.jpg

LM Start	2.38	Rating **	U	Issue No.	50
LM End	2.43	Issue Type +	En	Location *	LS
Category	Earthen Levee			GPS Latitude/Longitude	
				Start	End
Item	Vegetation			38.219029 °	38.218342 °
				-121.543831 °	-121.543837 °
DWR ID	DWR_RD0556_01_s_2018_50				
Comment Code					
V6 : Landscaping					
Inspector Comment

Manage landscaping.

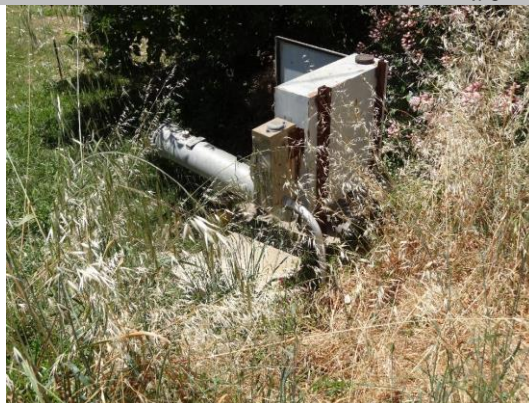
Photo 2 of 3 : UCIP_SP_2018_45803_74286.jpg

LM Start	2.44	Rating **	U	Issue No.	397 (cont)
LM End	2.44	Issue Type +	En	Location *

Closeup of 8-inch pipe, electrical conduit and box at LS berm.

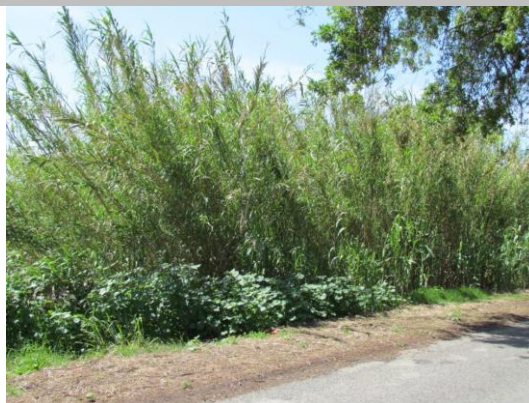
Photo 1 of 1 : SP_2018_RD0556_18_35_20180305_00021.jpg

LM Start	3.12	Rating **	U	Issue No.	35
LM End	3.14	Issue Type +	Ma	Location *	WS
Category	Earthen Levee			GPS Latitude/Longitude	
				Start	End
Item	Vegetation			38.211103 °	38.210970 °
				-121.537993 °	-121.538370 °
DWR ID	DWR_RD0556_01_s_2017_35				
Comment Code					
V2 : Remove the wild growth other than native grasses from the levee slopes.					
Inspector Comment					
Remove the unwanted wild growth from the waterside slope.

RD 556 Unit 1 levee mile 3.12-3.14 waterside shoulder and slope.

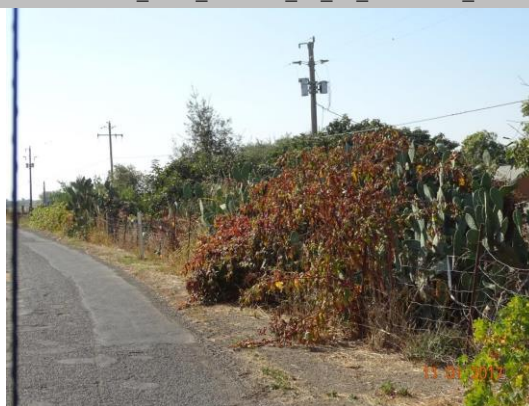
Photo 1 of 1 : SP_2018_RD0556_18_29_20180305_00014.jpg

LM Start	3.38	Rating **	U	Issue No.	29
LM End	3.42	Issue Type +	En	Location *	LS
Category	Earthen Levee			GPS Latitude/Longitude	
				Start	End
Item	Vegetation			38.208755 °	38.208191 °
				-121.541395 °	-121.541578 °
DWR ID	DWR_RD0556_01_f_2017_29				
Comment Code					
V6 : Landscaping					
Inspector Comment

Large cactus growing on shoulder and slope should be removed to allow inspection and access.

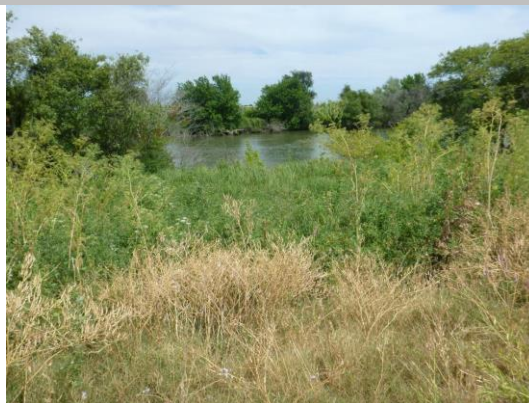
Photo 1 of 2 : SP_2018_RD0556_18_23_20180305_00005.jpg

LM Start	3.43	Rating **	A/W	Issue No.	23 (cont)
LM End	3.75	Issue Type +	Ma	Location *

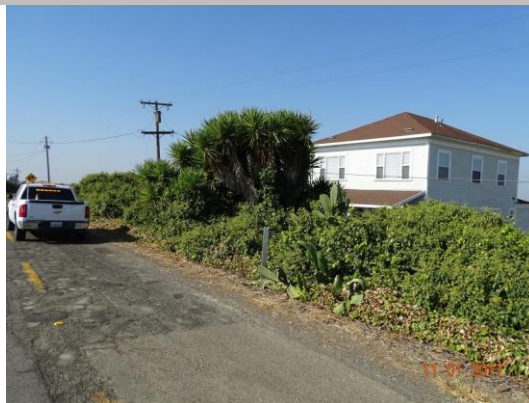
Photo 1 of 1 : SP_2018_RD0556_18_30_20180305_00015.jpg

LM Start	3.91	Rating **	U	Issue No.	30
LM End	3.91	Issue Type +	En	Location *	LS
Category	Earthen Levee			GPS Latitude/Longitude	
				Start	End
Item	Vegetation			38.201672 °	38.201672 °
				-121.542133 °	-121.542133 °
DWR ID	DWR_RD0556_01_f_2017_30				
Comment Code					
V6 : Landscaping					
Inspector Comment

Trim/thin landscaping to allow inspection and access to levee slope and toe.

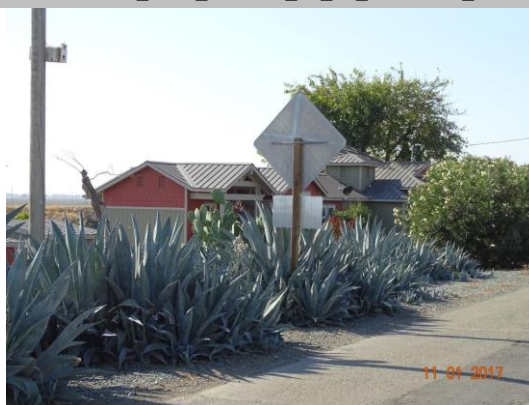
Photo 1 of 1 : SP_2018_RD0556_18_34_20180305_00020.jpg

LM Start	3.93	Rating **	U	Issue No.	34
LM End	3.98	Issue Type +	En	Location *	WS
Category	Earthen Levee			GPS Latitude/Longitude	
				Start	End
Item	Vegetation			38.201603 °	38.201273 °
				-121.542352 °	-121.543328 °
DWR ID	DWR_RD0556_01_f_2017_34				
Comment Code					
V6 : Landscaping					
Inspector Comment

Remove large cactus from waterside shoulder to allow inspection and access.

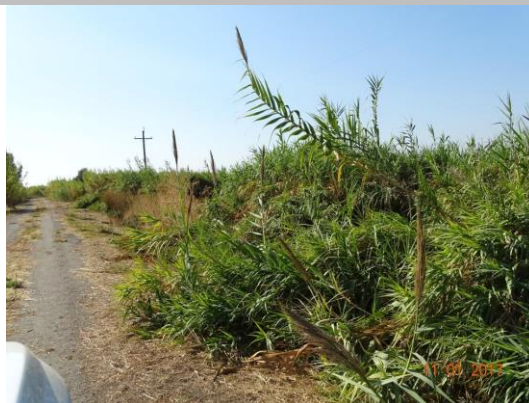
Photo 1 of 1 : SP_2018_RD0556_18_39_20180305_00026.jpg

LM Start	3.98	Rating **	U	Issue No.	39
LM End	5.48	Issue Type +	Ma	Location *	LS
Category	Earthen Levee			GPS Latitude/Longitude	
				Start	End
Item	Vegetation			38.201273 °	38.186464 °
				-121.543328 °	-121.562550 °
DWR ID	DWR_RD0556_01_f_2017_39				
Comment Code					
V2 : Remove the wild growth other than native grasses from the levee slopes.					
Inspector Comment					
Remove wild growth and arundo from landside slope and toe.

Control dense growth of wild vegetation, berry vines and arundo on landside to allow inspection and access.

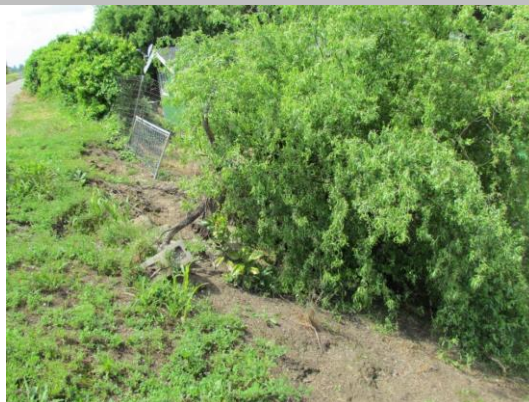
Photo 2 of 2 : SP_2018_RD0556_18_44_20180305_00029.jpg

LM Start	5.46	Rating **	U	Issue No.	44 (cont)
LM End	5.46	Issue Type +	En	Location *	LS

view from upstream.

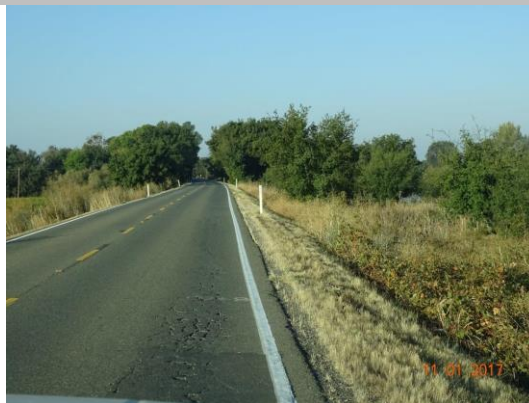
Photo 1 of 2 : SP_2018_RD0556_19_82_20180305_00023.jpg

LM Start	0.00	Rating **	M	Issue No.	82
LM End	5.71	Issue Type +	Ma	Location *	WS
Category	Earthen Levee			GPS Latitude/Longitude	
				Start	End
Item	Vegetation			38.200550 °	38.191937 °
				-121.544190 °	-121.567510 °
DWR ID	DWR_RD0556_02_s_2013_82				
Comment Code					
V2 : Remove the wild growth other than native grasses from the levee slopes.					
Inspector Comment

Waterside levee slope and shoulder have been mowed to 20' from

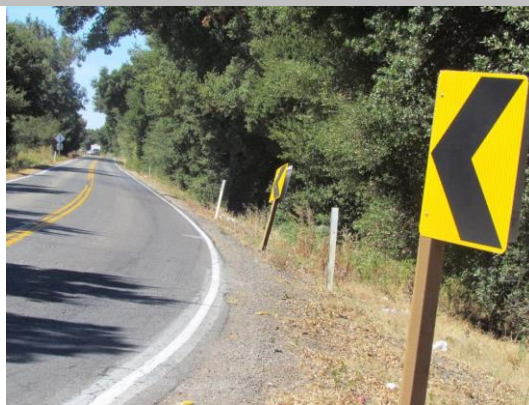
Photo 2 of 2 : SP_2018_RD0556_19_82_20180305_00024.jpg

LM Start	0.00	Rating **	M	Issue No.	82 (cont)
LM End	5.71	Issue Type +	Ma	Location *	WS

RD 556 Unit 2 looking downstream of waterside slope.

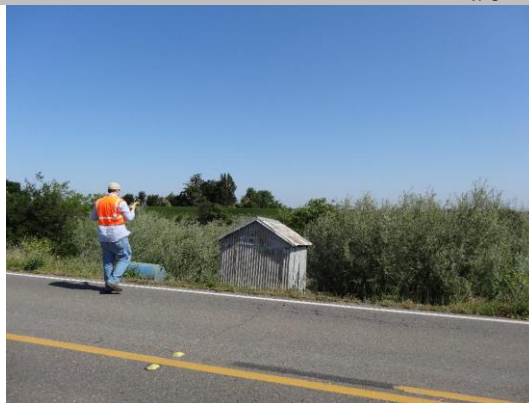
Photo 1 of 3 : UCIP_SP_2018_12512_20245.jpg

FS_ID:12512
DS_ID:20851
EP_NO: 11186
Repair Type: Non-Urgent
Crossing Status: Found
UCIP Comments: - a concrete box on LS- water is leaking from priming plastic tank and causing surface erosion on levee slope.
FIELD_STRUCT_DESC: 4-inch steel irrigation discharge pipe through the levee, 4.3 feet below the crown. Pump and gate valve in a pump house on the waterside (WS) berm. Siphon breaker and service pole on the landside (LS) slope. Concrete spill box with three 8-inch openings. (Retention of a 4-inch pipe through the levee, 4.3 feet below the crown, a pump in a pump house on the WS berm, and a siphon breaker and a service pole on the LS slope authorized under Automatic Board Order (ABO) issued as Permit No. 11186, 1975 - Margaret M. Marks).
[Additional Reference(s): DWR Levee Log. USACE Sacramento O&M Manual 103, June 1954, (Station ""J"" 192+00), 6-inch pipe referenced, invert elevation 18.8 feet].

WS- pump house on levee berm

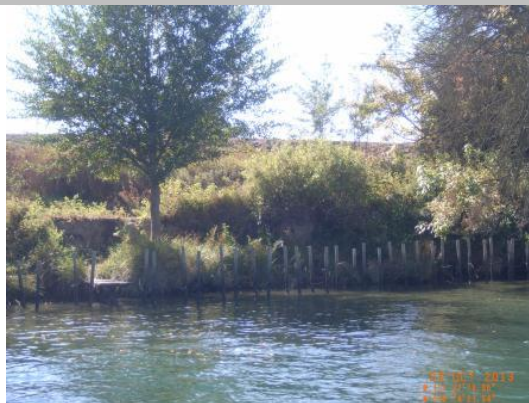
Photo 1 of 1 : SP_2018_RD0556_19_2_20180305_00002.jpg

LM Start	1.03	Rating **	M	Issue No.	2
LM End	1.15	Issue Type +	Ma	Location *	WS
Category	Supplemental			GPS Latitude/Longitude	
				Start	End
Item	2015 USACE Erosion Survey, DRAFT			38.238772 °	38.239265 °
				-121.536788 °	-121.538845 °
DWR ID	DWR_RD0556_02_f_2016_2				
Comment Code					
Inspector Comment					
1997 - Rock is in poor condition and has failed in many places. Scallops in berm with remnants of old rock in the toe area. 2005 - Brush boxes present. 2013 - Site extended upstream approximately 300 ft to include new erosion pockets. 2015: Minor new erosion at toe. [2015 Site ID: SAC 25-2 L]

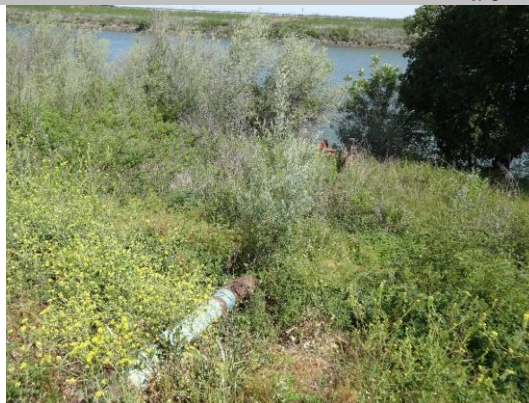
Photo 3 of 3 : UCIP_SP_2018_12573_20383.jpg

Comment Code						
Inspector Comment						
FS_ID:12573 DS_ID:20852 EP_NO: 11187 Repair Type: Non-Urgent Crossing Status: Found UCIP Comments: - gap between 6-inch pipe and 10-inch pipe needs to be sealed. FIELD_STRUCT_DESC: 6-inch steel irrigation discharge pipe sleeved through a 10-inch steel pipe through the levee, 4.8 feet below the crown. Pump on the riverbank. (Retention of a 10-inch pipe through the levee, 4.8 feet below the crown, a flap gate on the waterside (WS) end, landside (LS) end open, used to sleeve portable irrigation pipe, authorized under Automatic Board Order (ABO) issued as Permit No. 11187, 1975 - Ernest and Alvine Machado). [Additional Reference(s): DWR Levee Log]. FS Date: 4/25/2013

WS- 6-inch steel pipe on levee slope

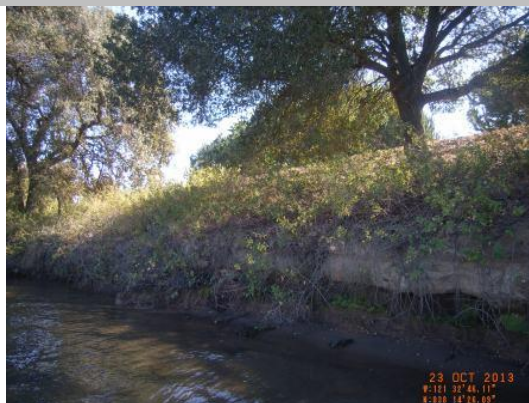
Photo 1 of 1 : SP_2018_RD0556_19_5_20180305_00005.jpg

LM Start	1.45	Rating **	M	Issue No.	5
LM End	1.59	Issue Type +	Ma	Location *	WS
Category	Supplemental			GPS Latitude/Longitude	
				Start	End
Item	2015 USACE Erosion Survey, DRAFT			38.240401 °	38.240772 °
				-121.544106 °	-121.546791 °
DWR ID	DWR_RD0556_02_f_2016_5				
Comment Code					
Inspector Comment					
1997 - Slow erosion of the berm at the waterline; bench below water. 2005 - Brush boxes present. 2010 - Minor new erosion. 2013 - There is little to no berm remaining at downstream end of this site. 2015: No observed changes. [2015 Site ID: SAC_24-8_L]

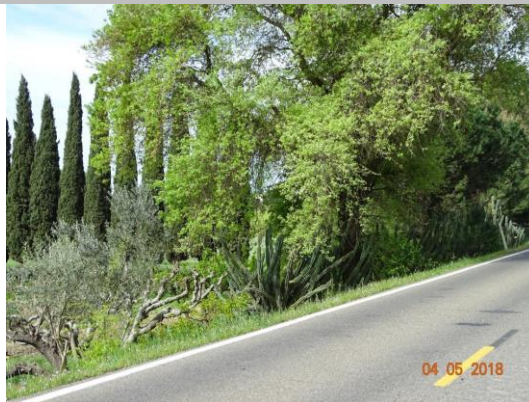
Photo 1 of 1 : SP_2018_RD0556_19_41_20180409_00062.jpg

LM Start	1.48	Rating **	U	Issue No.	41
LM End	1.48	Issue Type +	En	Location *	LS
Category	Earthen Levee			GPS Latitude/Longitude	
				Start	End
Item	Vegetation			38.240212 °	38.240212 °
				-121.544719 °	-121.544719 °
DWR ID	DWR_RD0556_02_s_2018_41				
Comment Code					
V6 : Landscaping					
Inspector Comment					
Remove cactus and thin other landscaping.

Cactus should be removed and other landscaping managed to allow access and inspection.

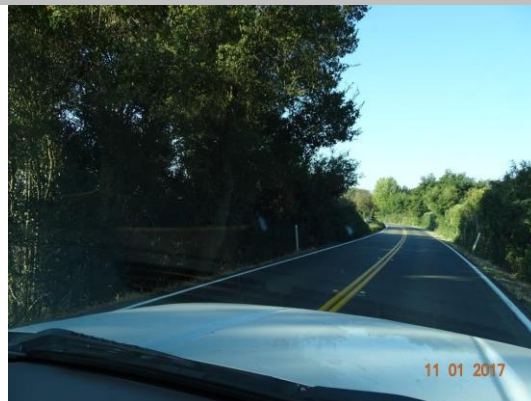
Photo 1 of 1 : SP_2018_RD0556_19_30_20180305_00015.jpg

LM Start	1.83	Rating **	U	Issue No.	30
LM End	1.99	Issue Type +	En	Location *	LS
Category	Earthen Levee			GPS Latitude/Longitude	
				Start	End
Item	Vegetation			38.240955 °	38.240024 °
				-121.551233 °	-121.553860 °
DWR ID	DWR_RD0556_02_f_2017_30				
Comment Code					
V6 : Landscaping					
Inspector Comment					
Remove/thin various landscaping including trees, bushes and large cactus.

Trim/thin oleanders on landside slope.

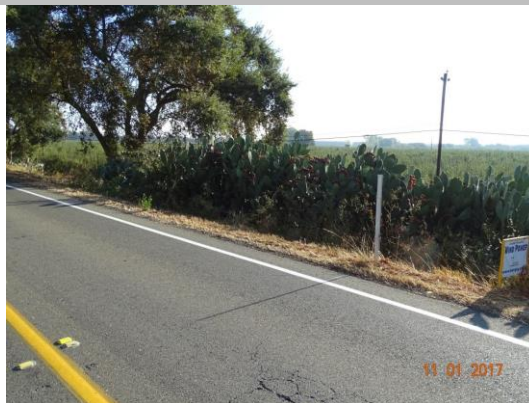
Photo 1 of 1 : SP_2018_RD0556_19_33_20180305_00018.jpg

LM Start	2.22	Rating **	U	Issue No.	33
LM End	2.22	Issue Type +	En	Location *	LS
Category	Earthen Levee			GPS Latitude/Longitude	
				Start	End
Item	Vegetation			38.237883 °	38.237883 °
				-121.556958 °	-121.556958 °
DWR ID	DWR_RD0556_02_f_2017_33				
Comment Code					
V6 : Landscaping					
Inspector Comment

Large growth of prickly pear cactus should be removed to allow inspection and access.

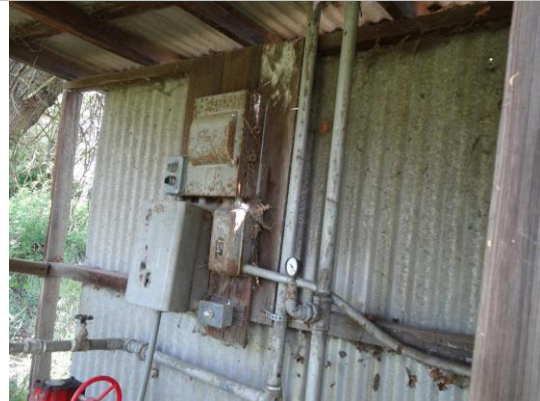
Photo 3 of 3 : UCIP_SP_2018_12574_20386.jpg

Comment Code					
Inspector Comment					
FS_ID:12574 DS_ID:20859 EP_NO: 11181 Repair Type: Non-Urgent Crossing Status: Found UCIP Comments: - Needs to clean CMP riser for proper functioning of siphon breaker. FIELD_STRUCT_DESC: 10-inch steel irrigation discharge pipe through the levee, 5.8 feet below the crown. Pump and gate valve in a pump house on the waterside (WS) slope. Siphon breaker and service pole on the landside (LS) slope. (Retention of a 10-inch pipe through the levee, 5.8 feet below the crown, a pump and a gate valve in a pump house on the WS slope, and a siphon breaker and a service pole on the LS slope authorized under Automatic Board Order (ABO) issued as Permit No. 11181, 1975 - Robert E. and G. P. Collins). [Additional Reference(s): DWR Levee Log. USACE Sacramento O&M Manual 103, June 1954, (Station ""J"" 115+25), invert elevation 18.5 feet]. FS Date: 4/25/2013

WS- power control panel and electric conduit in pump house.

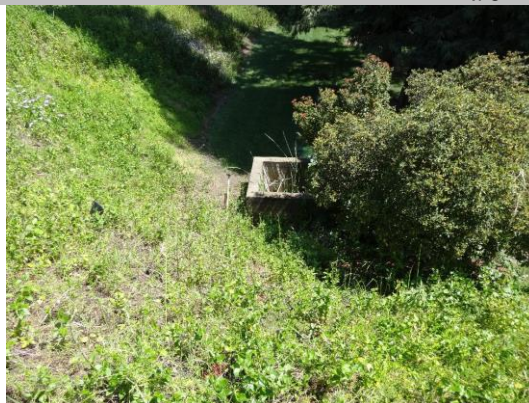
Photo 3 of 3 : UCIP_SP_2018_41713_20282.jpg

Comment Code						
Inspector Comment						
FS_ID:41713 DS_ID:20849 EP_NO: 11181 Repair Type: Non-Urgent Crossing Status: Found UCIP Comments: - Needs to clean siphon breaker CMP riser. FIELD_STRUCT_DESC: 6-inch irrigation discharge pipe of an unknown material through the levee, 6 feet below the crown. Pressure tank in a pump house on the waterside (WS) berm. Service pole, siphon breaker, and distribution box on the landside (LS) slope. (Retention of a 6-inch pipe through the levee, 6 feet below the crown; a pump, a gate valve, and a pressure tank on the WS berm; and a service pole on the LS slope authorized under Automatic Board Order (ABO) issued as Permit No. 11181, 1975 - Robert E. and G. P. Collins). [Additional Reference(s): DWR Levee Log]. FS Date: 4/25/2013

LS- concrete distribution box near toe of the levee

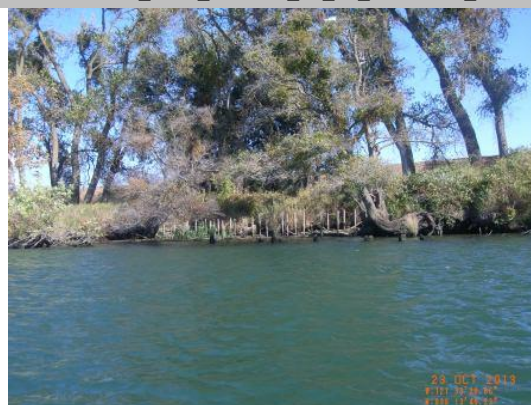
Photo 1 of 1 : SP_2018_RD0556_19_11_20180305_00009.jpg

LM Start	2.93	Rating **	A/W	Issue No.	11
LM End	3.04	Issue Type +	Ma	Location *	WS
Category	Supplemental			GPS Latitude/Longitude	
				Start	End
Item	2015 USACE Erosion Survey, DRAFT			38.228202 °	38.226601 °
				-121.555502 °	-121.555605 °
DWR ID	DWR_RD0556_02_f_2016_11				
Comment Code					
Inspector Comment					
1997 - Few scallops in berm, some getting close to levee toe. 2005 - Brush boxes present. 2012 - More erosion of the toe since last year. 2015: No observed changes. [2015 Site ID: SAC_23-3_L]

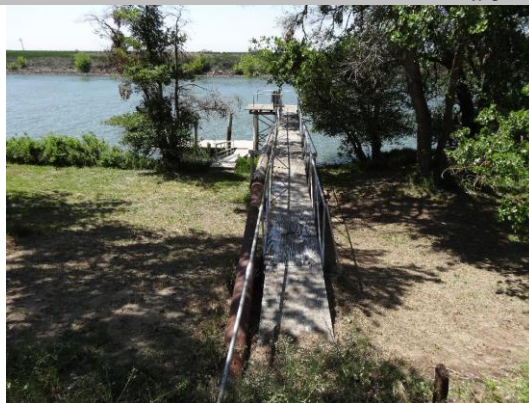
Photo 1 of 3 : UCIP_SP_2018_12525_20290.jpg

Comment Code						
Inspector Comment						
FS_ID:12525						
DS_ID:20862						
EP_NO: N/A						
Repair Type: Non-Urgent						
Crossing Status: Found						
UCIP Comments: - 9-inch steel pipe sleeved through 12-inch pipe.- needs to seal gap between two pipes.						
FIELD_STRUCT_DESC: 9-inch steel pipe sleeved through a 12-inch steel irrigation discharge pipe through the levee, 6 feet below the crown. Pump on a pile structure in the river. Steel walkway to the pump and wood steps on the waterside (WS) slope. Concrete spill box with two 8- inch openings. (Retention of a 12-inch pipe through the levee, 6 feet below the crown, a pump on a pile structure in the river, a steel walkway to the pump, and wood steps on the WS slope authorized under Automatic Board Order (ABO) issued as Permit No. 11193, 1975 - Gertrude M. Reid). [Additional Reference(s): DWR Levee Log. USACE Sacramento O&M Manual 103, June 1954, (Station ""J"" 80+79), invert elevation 18.3 feet].

WS- walkway, pump, and pipe on steel pile structure in the river.

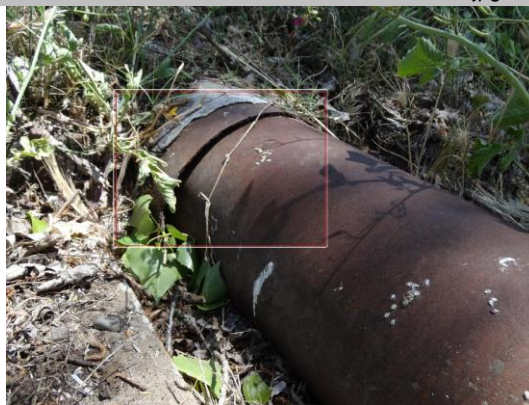
Photo 2 of 3 : UCIP_SP_2018_12525_20289.jpg

WS- 9-inch pipe sleeved through 10 inch steel pipe.

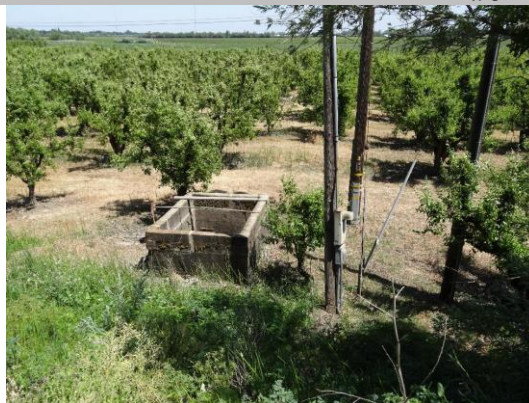
Photo 3 of 3 : UCIP_SP_2018_12525_20288.jpg

Comment Code						
Inspector Comment						
FS_ID:12525 DS_ID:20862 EP_NO: N/A Repair Type: Non-Urgent Crossing Status: Found UCIP Comments: - 9-inch steel pipe sleeved through 12-inch pipe.- needs to seal gap between two pipes. FIELD_STRUCT_DESC: 9-inch steel pipe sleeved through a 12-inch steel irrigation discharge pipe through the levee, 6 feet below the crown. Pump on a pile structure in the river. Steel walkway to the pump and wood steps on the waterside (WS) slope. Concrete spill box with two 8-inch openings. (Retention of a 12-inch pipe through the levee, 6 feet below the crown, a pump on a pile structure in the river, a steel walkway to the pump, and wood steps on the WS slope authorized under Automatic Board Order (ABO) issued as Permit No. 11193, 1975 - Gertrude M. Reid). [Additional Reference(s): DWR Levee Log. USACE Sacramento O&M Manual 103, June 1954, (Station ""J"" 80+79), invert elevation 18.3 feet]. FS Date: 4/25/2013

LS- a concrete spill box on landside of the levee.

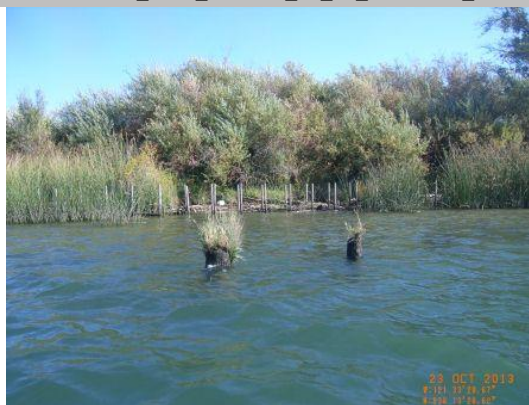
Photo 1 of 1 : SP_2018_RD0556_19_10_20180305_00008.jpg

LM Start	3.17	Rating **	M	Issue No.	10
LM End	3.28	Issue Type +	Ma	Location *	WS
Category	Supplemental			GPS Latitude/Longitude	
				Start	End
Item	2015 USACE Erosion Survey, DRAFT			38.224850 °	38.223233 °
				-121.555641 °	-121.555687 °
DWR ID	DWR_RD0556_02_f_2016_10				
Comment Code					
Inspector Comment					
2000 - Recently fallen cottonwood at the downstream end. 2005 - Empty brush boxes. 2011 - A few trees have fallen since last year. 2012 - Potential new tree popout since last year. 2013 - New erosion at downstream end of site and a recent tree pop-out observed. 2015: No observed changes. [2015 Site ID: SAC_23-2_L]

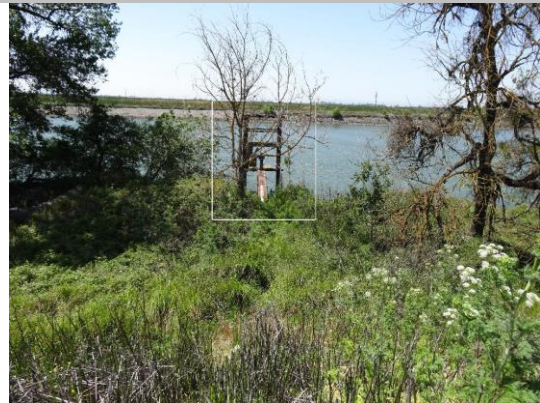
Photo 1 of 3 : UCIP_SP_2018_12527_20297.jpg

Comment Code					
Inspector Comment					
FS_ID:12527 DS_ID:20863 EP_NO: 11181 Repair Type: Non-Urgent Crossing Status: Found UCIP Comments: - needs to fix siphon breaker FIELD_STRUCT_DESC: 10-inch steel irrigation discharge pipe through the levee, 4.8 feet below the crown. Steel walkway to the pump on a pile structure in the river. Siphon breaker on the waterside (WS). Service pole on the landside (LS) slope. Concrete spill box with two 15-inch openings on the LS. (Retention of a 10-inch pipe through the levee, 4.8 feet below the crown, a steel walkway to the pump on a pile structure in the river, and a siphon breaker and a service pole on the LS slope authorized under Automatic Board Order (ABO) issued as Permit No. 11181, 1975 - Robert E. and G. P. Collins). [Additional Reference(s): DWR Levee Log. USACE Sacramento O&M Manual 103, June 1954, (Station ""J"" 58+00), invert elevation 18.2 feet]. FS Date: 4/25/2013

WS- pump, pipe, and walkway on steel structure in the stream.

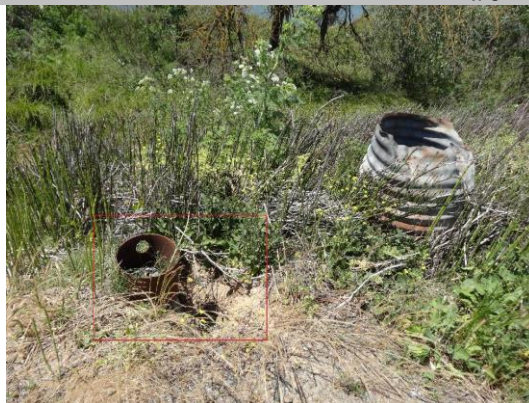
Photo 2 of 3 : UCIP_SP_2018_12527_20296.jpg

Comment Code						
Inspector Comment						
FS_ID:12527 DS_ID:20863 EP_NO: 11181 Repair Type: Non-Urgent Crossing Status: Found UCIP Comments: - needs to fix siphon breaker FIELD_STRUCT_DESC: 10-inch steel irrigation discharge pipe through the levee, 4.8 feet below the crown. Steel walkway to the pump on a pile structure in the river. Siphon breaker on the waterside (WS). Service pole on the landside (LS) slope. Concrete spill box with two 15-inch openings on the LS. (Retention of a 10-inch pipe through the levee, 4.8 feet below the crown, a steel walkway to the pump on a pile structure in the river, and a siphon breaker and a service pole on the LS slope authorized under Automatic Board Order (ABO) issued as Permit No. 11181, 1975 - Robert E. and G. P. Collins). [Additional Reference(s): DWR Levee Log. USACE Sacramento O&M Manual 103, June 1954, (Station ""J"" 58+00), invert elevation 18.2 feet]. FS Date: 4/25/2013

WS- siphon breaker and abandoned CMP riser laying adjacent to it.

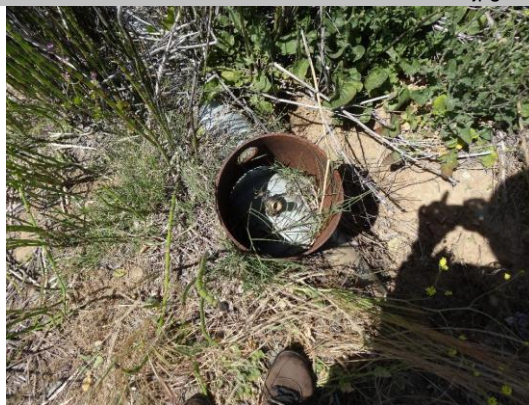
Photo 3 of 3 : UCIP_SP_2018_12527_20295.jpg

WS- siphon breaker on levee slope.

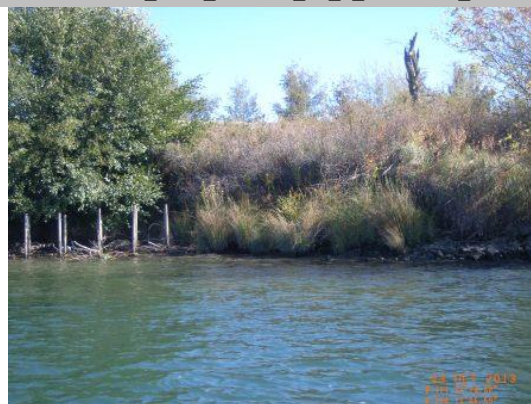
Photo 1 of 1 : SP_2018_RD0556_19_8_20180305_00007.jpg

LM Start	3.58	Rating **	M	Issue No.	8
LM End	3.64	Issue Type +	Ma	Location *	WS
Category	Supplemental		GPS Latitude/Longitude		
			Start	End	
Item	2015 USACE Erosion Survey, DRAFT		38.218951 °	38.218104 °	
			-121.556689 °	-121.556819 °	
DWR ID	DWR_RD0556_02_f_2016_8				
Comment Code					
Inspector Comment					
1997 - Scallops into berm and very close to levee toe. 2005 - Brush boxes present. 2011 - New toe scour and freshly fallen tree. 2012 - New tree popout has taken significant portion of soil out of the levee. 2015: No observed changes. [2015 Site ID: SAC_22-7_L]

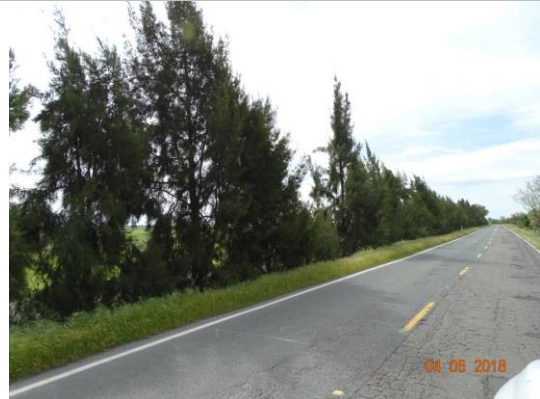
Photo 1 of 1 : SP_2018_RD0556_19_49_20180409_00063.jpg

LM Start	3.58	Rating **	U	Issue No.	49
LM End	3.74	Issue Type +	En	Location *	LS
Category	Earthen Levee			GPS Latitude/Longitude	
				Start	End
Item	Vegetation			38.218889 °	38.216543 °
				-121.556388 °	-121.556777 °
DWR ID	DWR_RD0556_02_s_2018_49				
Comment Code					
V6 : Landscaping					
Inspector Comment					
Row of evergreen trees blocks inspection and access. Should be trimmed to 5' above levee.

Row of landscaping trees blocks inspection and access.

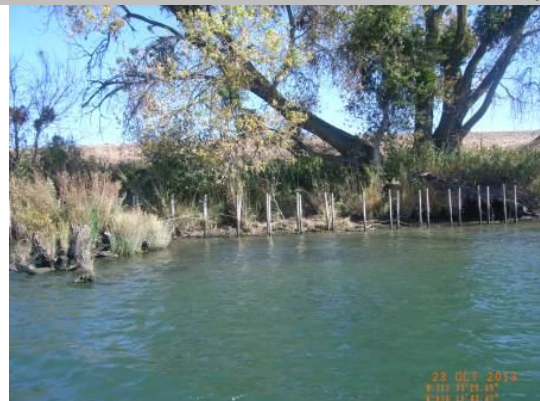
Photo 1 of 1 : SP_2018_RD0556_19_4_20180305_00004.jpg

LM Start	3.95	Rating **	M	Issue No.	4
LM End	4.12	Issue Type +	Ma	Location *	WS
Category	Supplemental			GPS Latitude/Longitude	
				Start	End
Item	2015 USACE Erosion Survey, DRAFT			38.213581 °	38.211112 °
				-121.557197 °	-121.557042 °
DWR ID	DWR_RD0556_02_f_2016_4				
Comment Code					
Inspector Comment					
2002 - Spot rock along berm, but not in the erosion pockets. 2005 - Some new minor stone revetment at the upstream end. Brush boxes present. 2006 - Currently installing new brush in downstream brush boxes. 2007 - Rock in middle portion for about 150 ft. 2010 - Some attempt at repairs but still has pockets of erosion. 2012 - More erosion along the toe. 2015: No observed changes. [2015 Site ID: SAC_22-5_L]

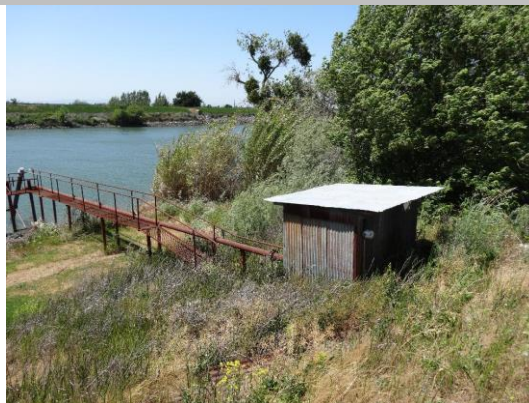
Photo 1 of 3 : UCIP_SP_2018_12543_20302.jpg

FS_ID:12543
DS_ID:20864
EP_NO: 11197
Repair Type: Non-Urgent
Crossing Status: Found
UCIP Comments: Electric control panel in pump house. Needs cleaning of CMP riser on landside.
FIELD_STRUCT_DESC: 6-inch steel irrigation discharge pipe through the levee, 6.5 feet below the crown. Slant pump on a steel pile structure in the river. Walkway to the pump. Gate valve in a pump house on the waterside (WS) slope. Siphon breaker and service poles on the landside (LS) slope. Concrete standpipe on the LS. (Retention of a 6-inch pipe through the levee, 6.5 feet below the crown, a pump and a gate valve in a pump house on the WS slope, and a siphon breaker and a service pole on the LS slope authorized under Automatic Board Order (ABO) issued as Permit No. 11197, 1975 - Richard T. and Mary B. Souza). [Additional Reference(s): DWR Levee Log. USACE Sacramento O&M Manual 103, June 1954, (Station "J" 32+40), invert elevation 18.1 feet].

WS- pipe and pump on steel pile structure. Steel walkway from pump house to the pump on steel structure.

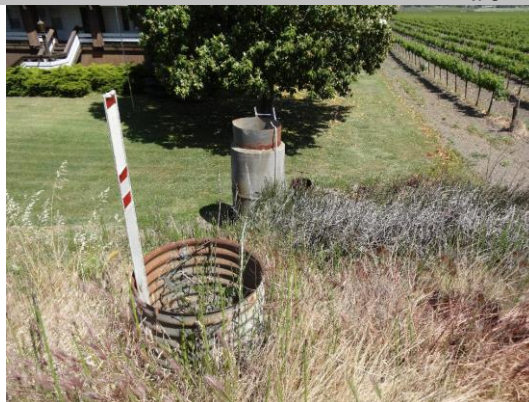
Photo 2 of 3 : UCIP_SP_2018_12543_20301.jpg

LS- siphon breaker in CMP riser and concrete standpipe behind CMP riser.

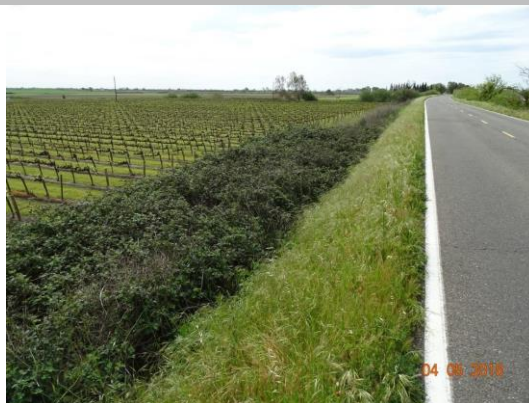
Photo 1 of 1 : SP_2018_RD0556_19_52_20180409_00065.jpg

LM Start	4.01	Rating **	U	Issue No.	52
LM End	4.38	Issue Type +	Ma	Location *	LS
Category	Earthen Levee			GPS Latitude/Longitude	
				Start	End
Item	Vegetation			38.212662 °	38.207293 °
				-121.556808 °	-121.556837 °
DWR ID	DWR_RD0556_02_s_2018_52				
Comment Code					
V2 : Remove the wild growth other than native grasses from the levee slopes.					
Inspector Comment					
Remove berry vines to allow inspection and access.

Berry vines on landside should be removed to allow inspection and access.

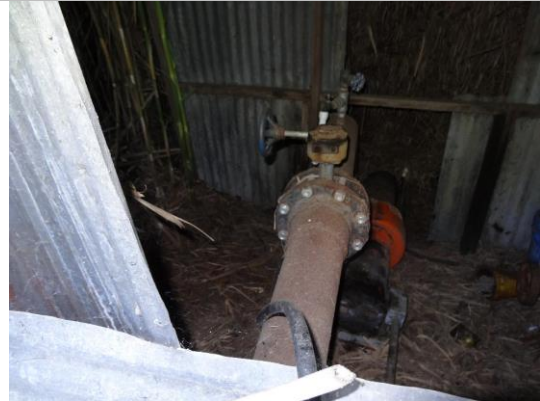
Photo 3 of 3 : UCIP_SP_2018_12545_20308.jpg

Comment Code						
Inspector Comment						
FS_ID:12545 DS_ID:20865 EP_NO: 11194 Repair Type: Non-Urgent Crossing Status: Found UCIP Comments: - CMP riser found abandoned on LS slope. Due to dense vegetation siphon breaker could not be found.- Dense vegetation on both sides of the levee.- Oil leaks from pump set. FIELD_STRUCT_DESC: 8-inch steel irrigation discharge pipe through the levee, 6.7 feet below the crown. Pump and gate valve in a pump house on the waterside (WS) slope. Siphon breaker on the landside (LS) slope. (Retention of an 8-inch pipe through the levee, 6.7 feet below the crown, a pump and a gate valve in a pump house on the WS slope, and a siphon breaker on the LS slope authorized under Automatic Board Order (ABO) issued as Permit No. 11194, 1975 - Gerald E. and William M. Robinson, et al.). [Additional Reference(s): DWR Levee Log. USACE Sacramento O&M Manual 103, June 1954, (Station ""J"" 18+20), invert elevation 18 feet]. FS Date: 4/25/2013

WS- pump, gate valve and pipe in pump house.

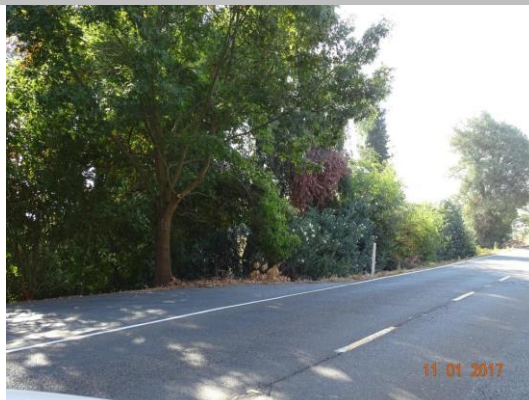
Photo 1 of 1 : SP_2018_RD0556_19_36_20180305_00021.jpg

LM Start	4.41	Rating **	M	Issue No.	36
LM End	4.41	Issue Type +	En	Location *	LS
Category	Earthen Levee			GPS Latitude/Longitude	
				Start	End
Item	Vegetation			38.206915 °	38.206915 °
				-121.556818 °	-121.556818 °
DWR ID	DWR_RD0556_02_f_2017_36				
Comment Code					
V6 : Landscaping					
Inspector Comment

Oleanders, trees and other landscaping should be trimmed to allow inspection and access to landside slope and toe.

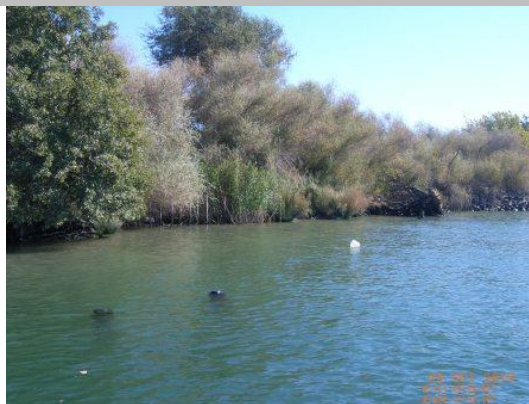
Photo 1 of 1 : SP_2018_RD0556_19_7_20180305_00006.jpg

LM Start	4.45	Rating **	M	Issue No.	7
LM End	4.49	Issue Type +	Ma	Location *	WS
Category	Supplemental			GPS Latitude/Longitude	
				Start	End
Item	2015 USACE Erosion Survey, DRAFT			38.206377 °	38.205729 °
				-121.557184 °	-121.557108 °
DWR ID	DWR_RD0556_02_f_2016_7				
Comment Code					
Inspector Comment					
2013 - Erosion pockets encroaching on levee foundation. 2015: No observed changes. [2015 Site ID: SAC_21-9_L]

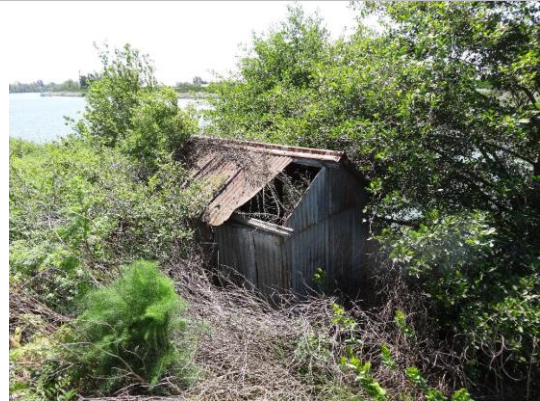
Photo 1 of 3 : UCIP_SP_2018_12546_20314.jpg

Comment Code						
Inspector Comment						
FS_ID:12546 DS_ID:20866 EP_NO: 11940 Repair Type: Non-Urgent Crossing Status: Found UCIP Comments: - Abandoned crossing.- Siphon breaker on LS not found due to dense vegetation, - An abandoned CMP riser and service pole found on LS.- It may need to be properly abandoned. FIELD_STRUCT_DESC: *ABANDONED* 6-inch steel irrigation discharge pipe through the levee, 6.7 feet below the crown. Pump and gate valve in a pump house on the waterside (WS) slope. Siphon breaker and service pole on the landside (LS) slope. (Retention of a 6-inch pipe through the levee, 6.5 feet below the crown, a pump and a gate valve in a pump house on the WS slope, and a siphon breaker and a service pole on the LS slope authorized under Automatic Board Order (ABO) issued as Permit No. 11194, 1975 - Gerald E. and William M. Robinson, et al.). [Additional Reference(s): DWR Levee Log. USACE Sacramento O&M Manual 103, June 1954, (Station ""J"" 2+73), invert elevation 18 feet]. FS Date: 4/25/2013

WS- abandoned pump house on levee slope. Dense vegetation on levee slope.

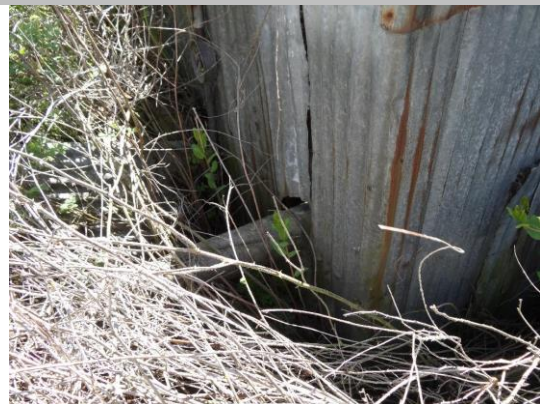
Photo 2 of 3 : UCIP_SP_2018_12546_20313.jpg

WS- pipe daylight from levee slope to pump house.

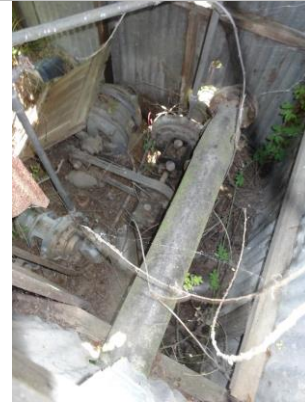
Photo 3 of 3 : UCIP_SP_2018_12546_20315.jpg

Comment Code						
Inspector Comment						
FS_ID:12546 DS_ID:20866 EP_NO: 11940 Repair Type: Non-Urgent Crossing Status: Found UCIP Comments: - Abandoned crossing.- Siphon breaker on LS not found due to dense vegetation, - An abandoned CMP riser and service pole found on LS.- It may need to be properly abandoned. FIELD_STRUCT_DESC: *ABANDONED* 6-inch steel irrigation discharge pipe through the levee, 6.7 feet below the crown. Pump and gate valve in a pump house on the waterside (WS) slope. Siphon breaker and service pole on the landside (LS) slope. (Retention of a 6-inch pipe through the levee, 6.5 feet below the crown, a pump and a gate valve in a pump house on the WS slope, and a siphon breaker and a service pole on the LS slope authorized under Automatic Board Order (ABO) issued as Permit No. 11194, 1975 - Gerald E. and William M. Robinson, et al.). [Additional Reference(s): DWR Levee Log. USACE Sacramento O&M Manual 103, June 1954, (Station ""J"" 2+73), invert elevation 18 feet]. FS Date: 4/25/2013

WS- abandoned gate valve, pump, and pipe in pump house

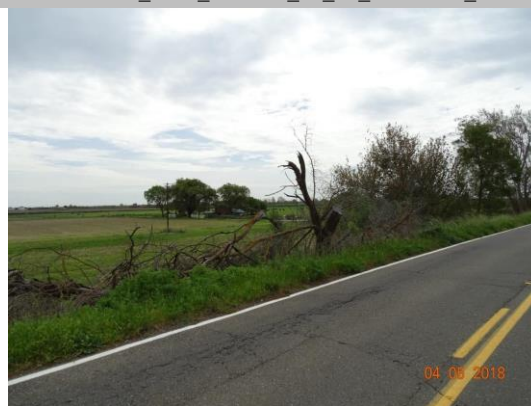
Photo 1 of 1 : SP_2018_RD0556_19_56_20180409_00068.jpg

LM Start	4.56	Rating **	U	Issue No.	56
LM End	4.56	Issue Type +	Ma	Location *	LS
Category	Earthen Levee			GPS Latitude/Longitude	
				Start	End
Item	Encroachments			38.204666 °	38.204666 °
				-121.556813 °	-121.556813 °
DWR ID	DWR_RD0556_02_s_2018_56				
Comment Code					
TR : Tree or limb					
Inspector Comment					
Remove large fallen tree.

Fallen tree on landside should be removed.
